## EVALUATION OF REAL ACCIDENTS

ir. D. CHRISTIAENS IBB-Expertisen

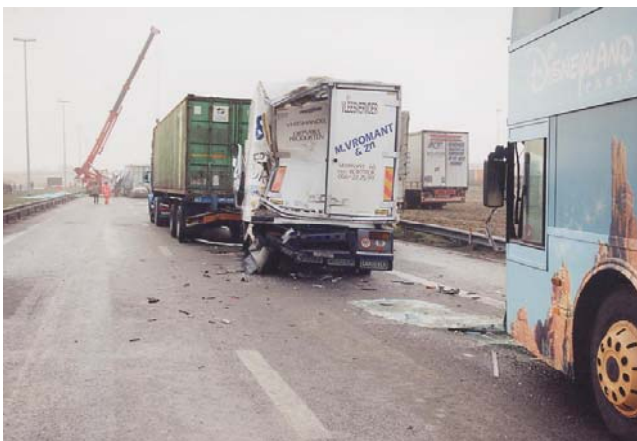
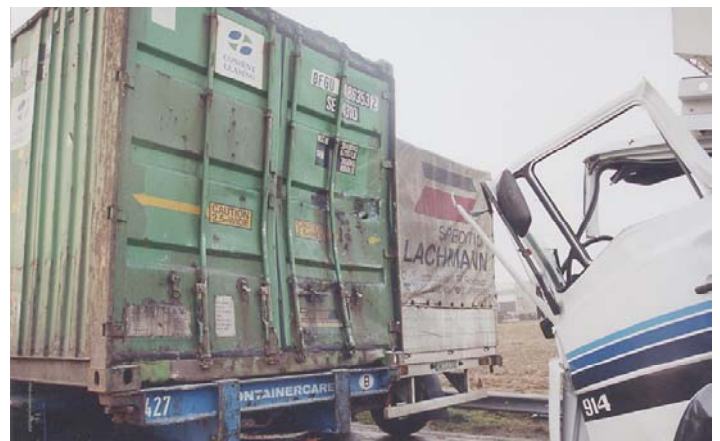
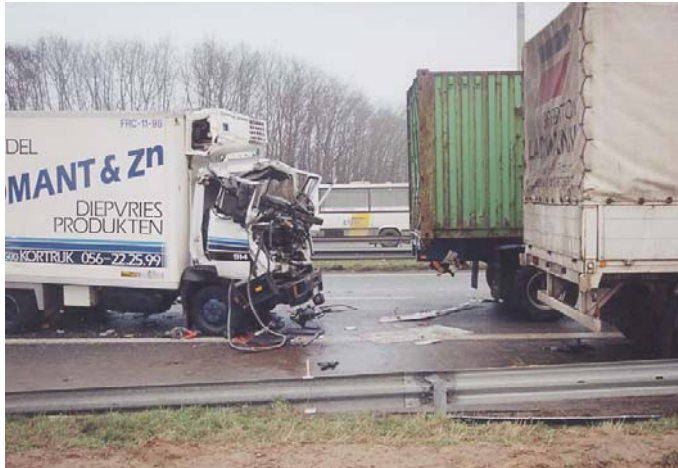
The tractor semi-trailer with the green container stopped without any collision at the end of the traffic jam in the right lane. A smaller refrigerator truck arrived and ran into the green container. And a bus hit the refrigerator truck.

What was the order of these two collisions? Did the bus smash the smaller truck into the green container or had the driver of the refrigerator truck already crashed into the green container, before being hit by the bus?

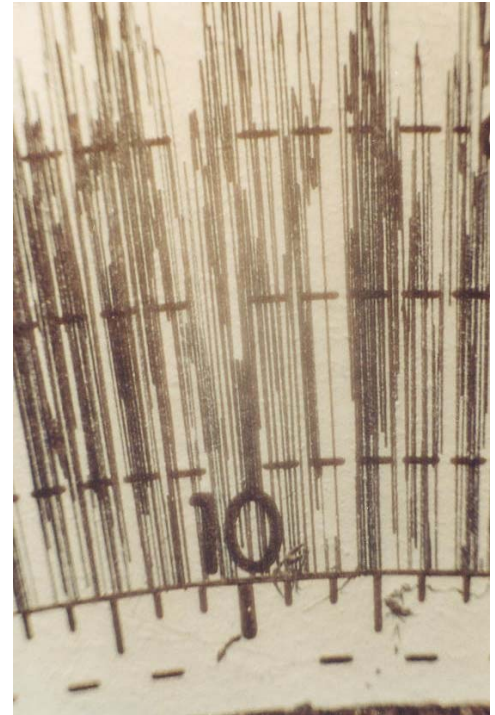
speedometer card of the small refrigerator truck had been left several days in the speedometer and in this way had become difficult to read. Nevertheless a typical collision disturbance of the writing pen of the speedometer was visible on the zero-line of the card at the time of the accident. It meant that the refrigerator truck ran into the container with his wheels blocked by the brakes.

The cabin of the refrigerator truck was compressed in the collision on the green container.

The driver and his co-driver were both mortally wounded.

The difference between the structure stiffness of such a steel transport container and the truck-cabin appeared clearly from the damage aspect of both collision partners. This stiffness difference was fatal in this collision.

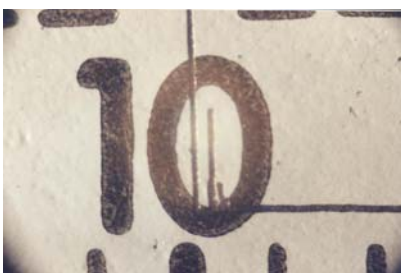
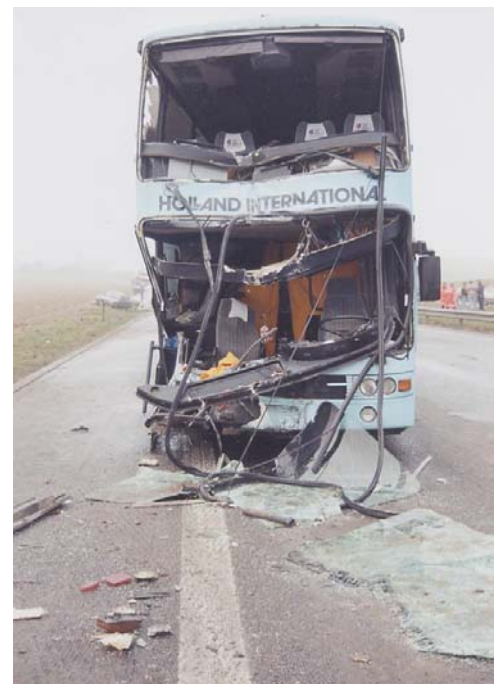
The bus hit the small refrigerator truck with an overlap of about 50%.

In this collision the bus driver's companion was killed.

The damage aspect illustrates the low stiffness of the front of such a bus.

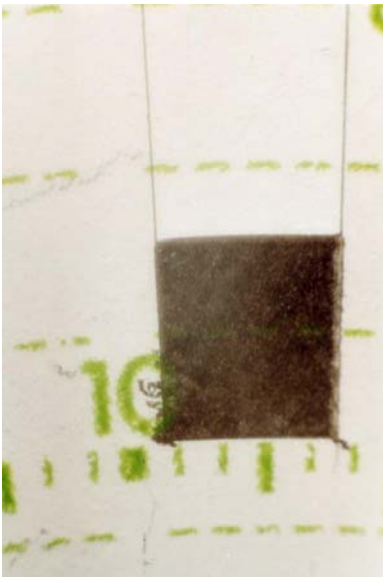
The answer to the question whether the bus first hit the refrigerator truck and smashed it into the green steel container, or crashed into the refrigerator truck after it ran itself into the container, found his answer in the speedometer card of the tractor/semi-trailer with the green container. On this card two clearly separated acceleration peaks, caused by rear impact, appeared after the stop of the container truck. They indicated that

at first the refrigerator truck collided with the green container and that only thereafter the bus arrived and hit the wreck of the refrigerator truck at the rear.

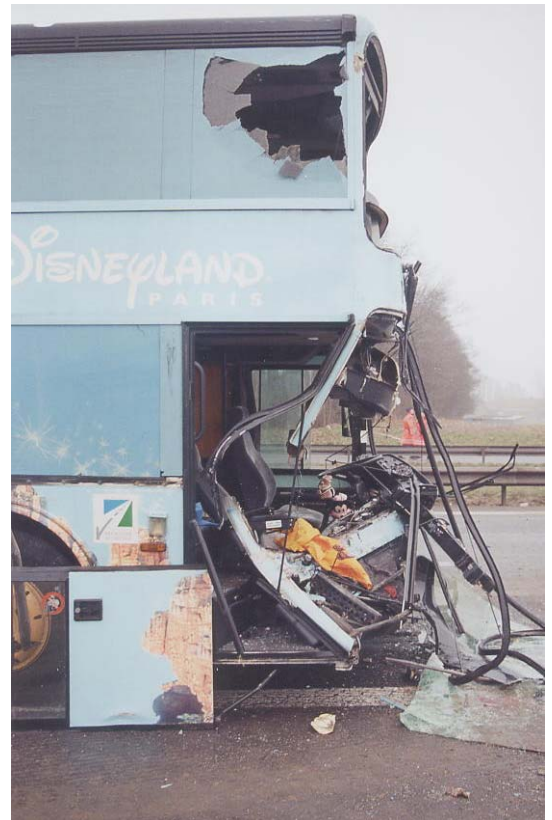
The speedometer card of the bus allowed no conclusions concerning the speed of the bus before collision and at the moment of collision.

The bus also arrived into that collision with his wheels blocked by the brakes. The vibration of the speedometer writing needle lies on the zero line of the card.

On top of that the electrical cabling to the speedometer of the bus was damaged in the collision so that the speedometer ran into his fraud alarm mode.

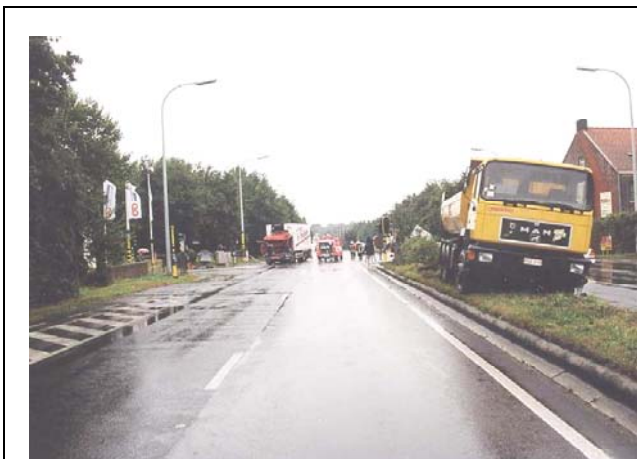
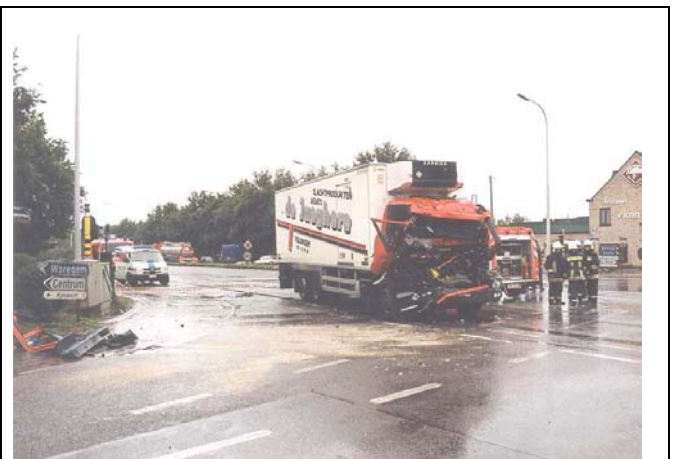
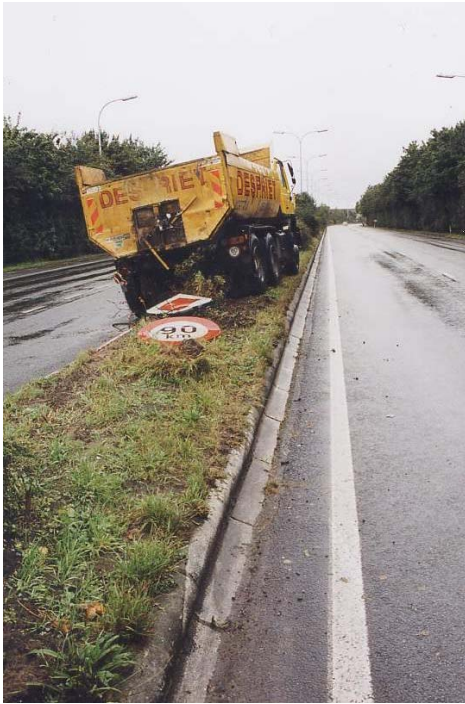
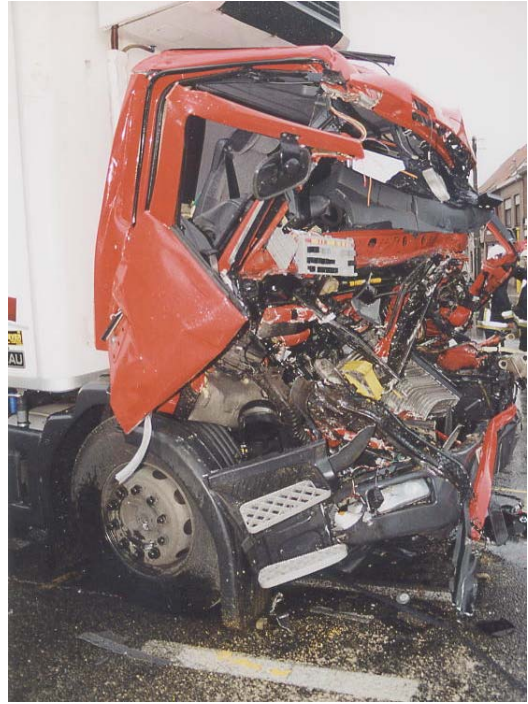
A truck (yellow, MAN) was waiting at the traffic lights. A second truck (red, Volvo) crashed into it from behind.

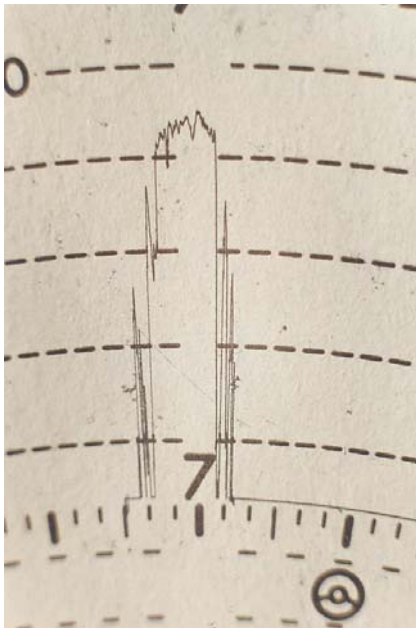
The incoming truck, i.e. the red Volvo, had a weight of 16,5 tons and, according to his speedometer card, hit the yellow MAN with a speed of about 72 km/h.

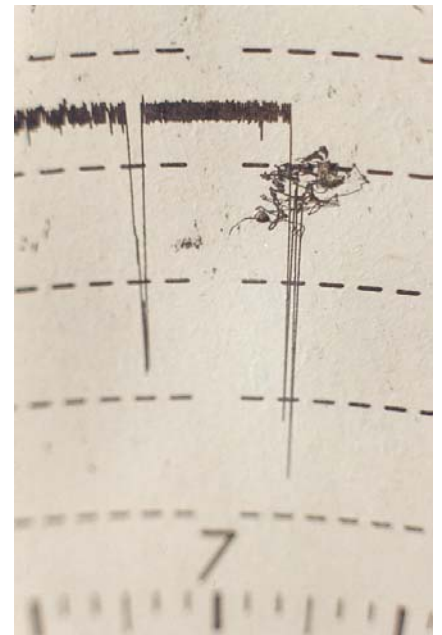
The MAN had a weight of about 11,86 tons and, according to his speedometer card, it was accelerated due to the collision from zero speed up to 35 km/h.

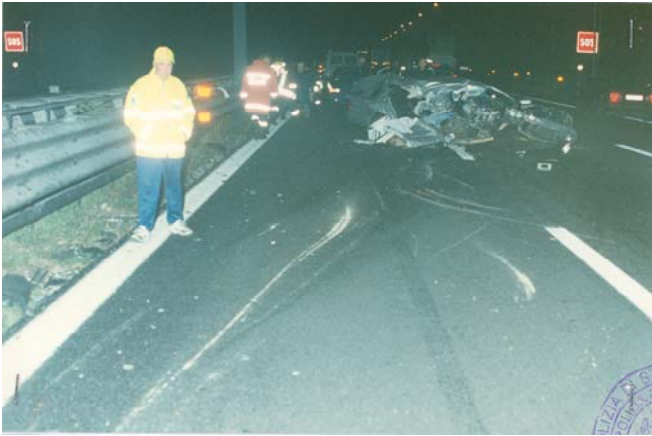
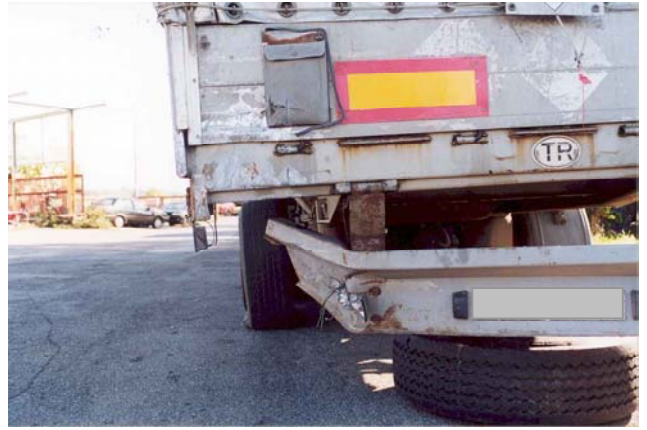
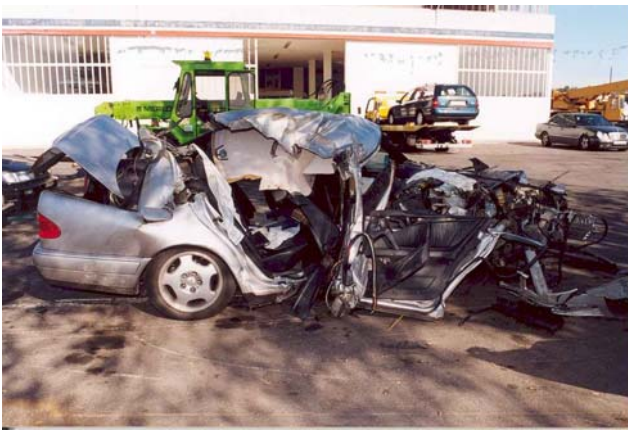
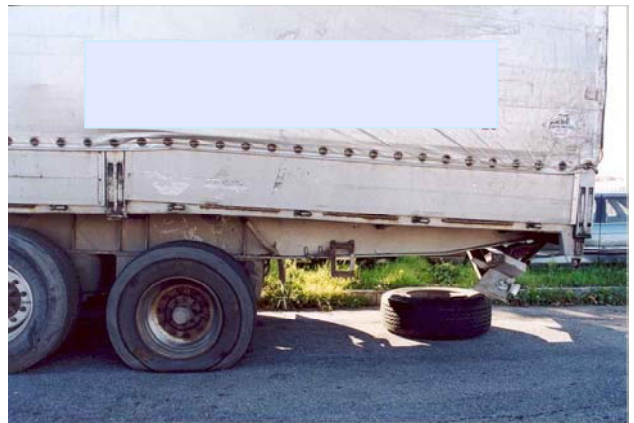
2.1.3.1. A Mercedes E-class driver with a passenger drove at night on a three-lane motorway and hit from behind a tractor with semi-trailer, which apparently changed lane in front of him.

EES estimated ca. 60 km/h

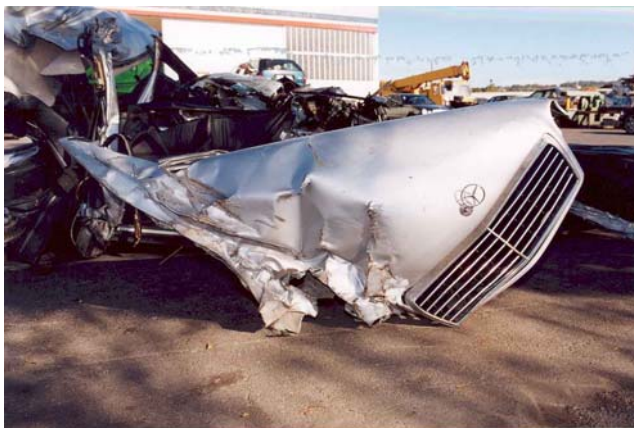
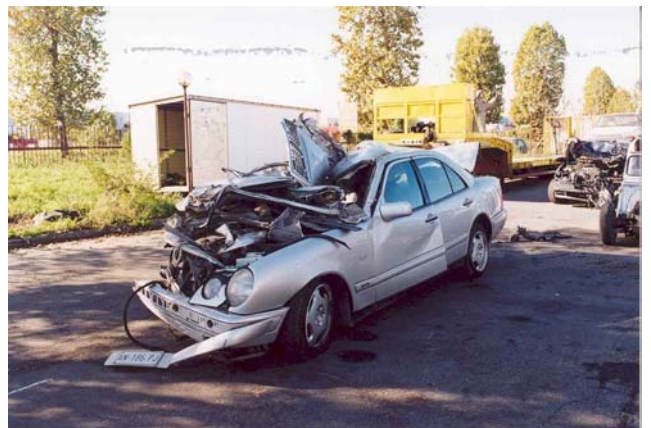
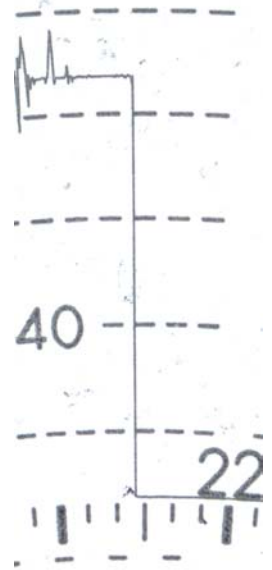
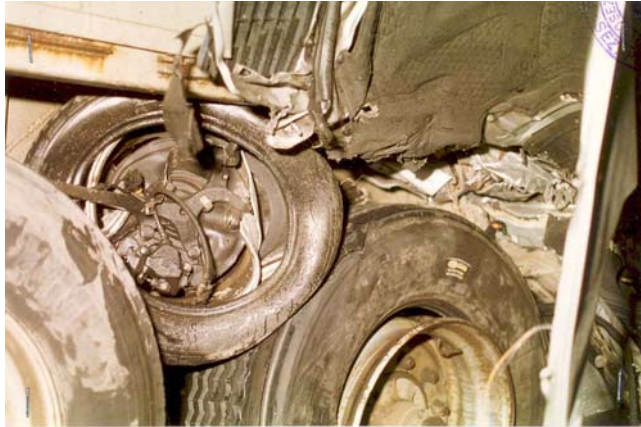
The collision happened in the second of the three lanes. The tractor semi-trailer, according to his speedometer card, drove at a speed of about 85 km/h at the moment of the accident. The Mercedes spun about 90 meters further before coming to stand still. The front passenger was killed in this accident.

In such a case only an estimation of the EES-value of the damage can offer some help. In this case the Mercedes was even tilted up by the left rear wheel of the semi-trailer and the right front corner of the Mercedes, and the right front wheel remained clamped between the wheels of the semi-trailer and the cargo floor. The Daimler Chrysler Accident Research Department was contacted for help. This department estimated the EES-value of the damage of the Mercedes at about 60 km/h.

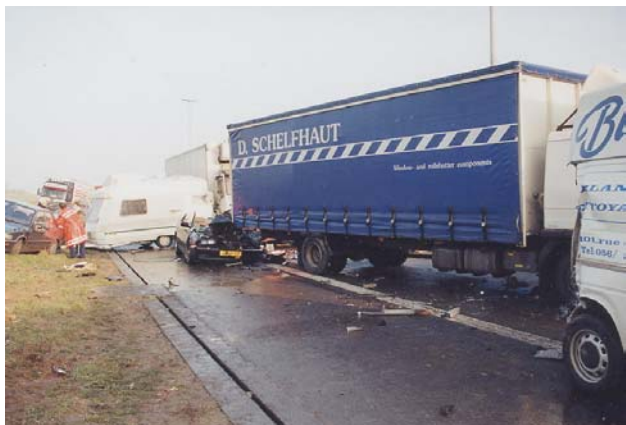
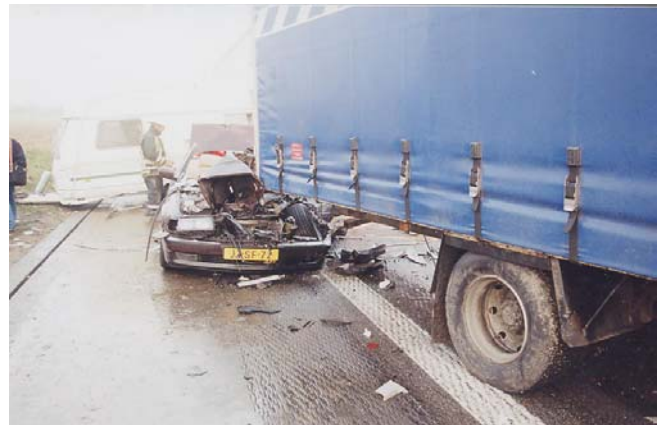
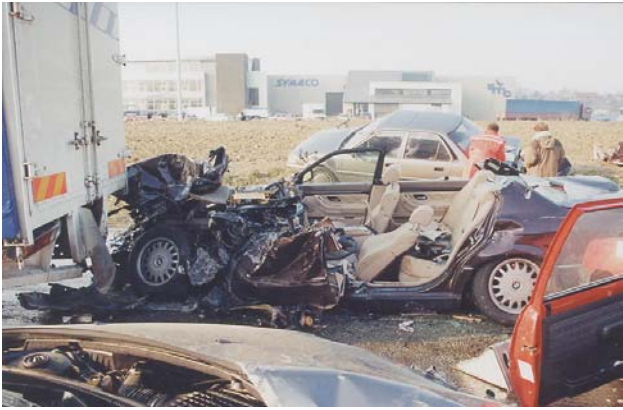
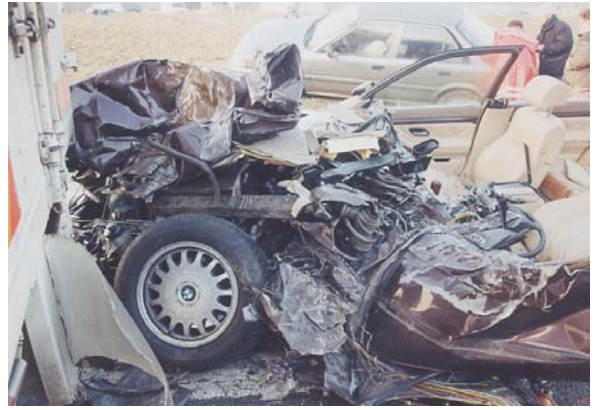
2.1.3.2. In the already mentioned pile-up collision on the 29.01.1998 on the motorway E17 in Rekkem an almost identical collision took place. A BMW-7 driver discovered too late the traffic jam in the fog, tried to pull out to the right and crashed into the rear right corner of a truck that already came to standstill. It was a collision with narrow overlap and the truck had a long overhang of its cargo floor.

The BMW driver was killed in this accident. The passenger at his right was hardly wounded. The rescue team cut off the roof from the car. This made it impossible to estimate the EES-value of the damage in a more or less narrow margin.

The deformation energy absorbed by the rear bumper of the truck and its supports is not known.

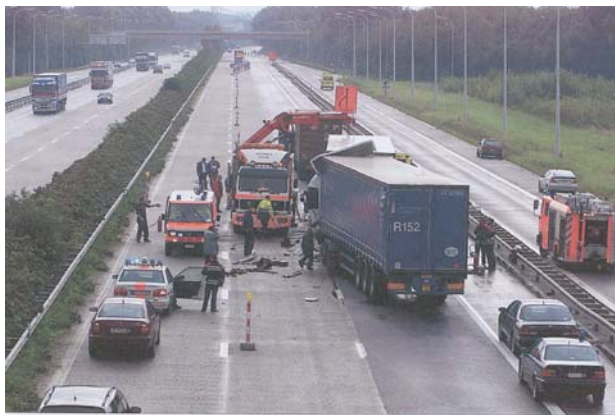
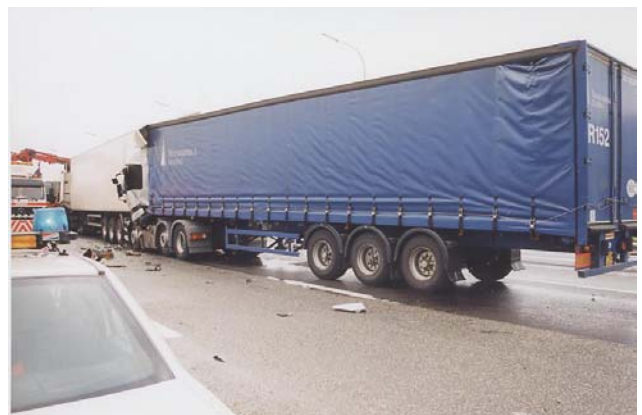
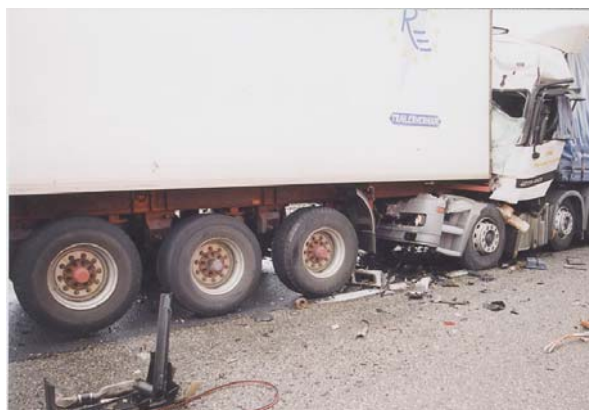
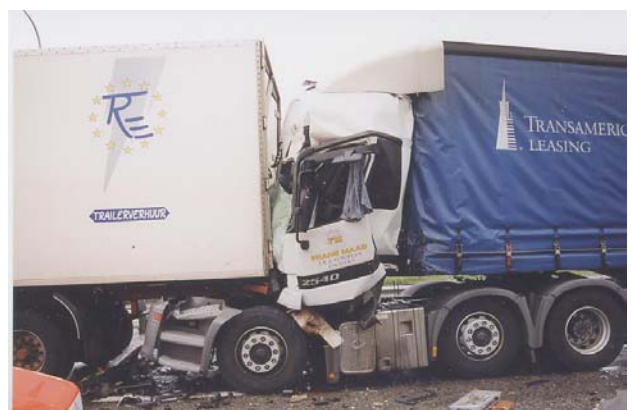
The driver of a tractor with semi-trailer, apparently inadvertent, drove on a motorway, which was partly blocked for maintenance, and crashed into a refrigerator semi-trailer, already at standstill at the end of the queue.

Also in rear-end collisions of a tractor on a semi-trailer, one frequently sees that the chassis of the incoming tractor goes underneath the cargo-floor of the semi-trailer, which was hit, whereas at the same time the cabin of the tractor is compressed between the cargo space of the trailer in front and his own cargo trailer.

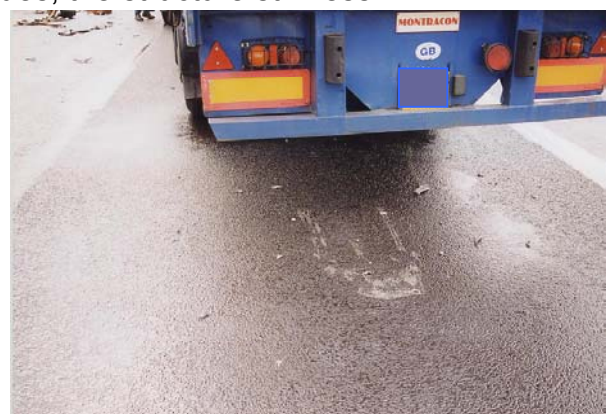
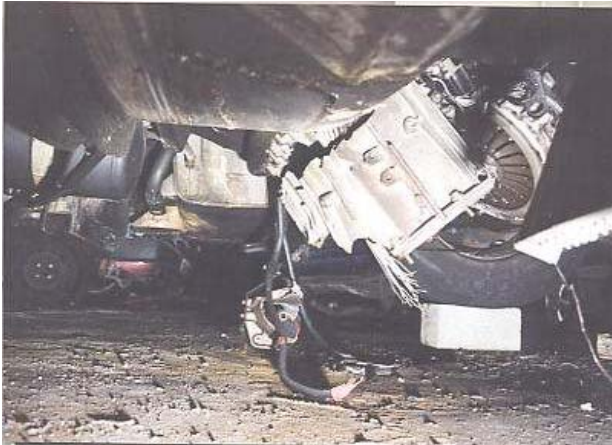
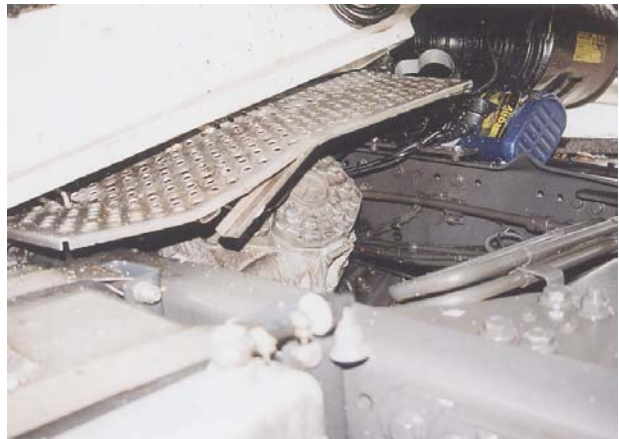
In the shown accident the precise collision area could be located by means of a number of scratches in the road surface. These scratches were caused by the gearbox of the incoming tractor (Mercedes Actros 2540). This gearbox was torn from the motor block in the collision and touched the road surface. [The motor block tipped when the chassis of the tractor went under the cargo floor of the trailer in front.]

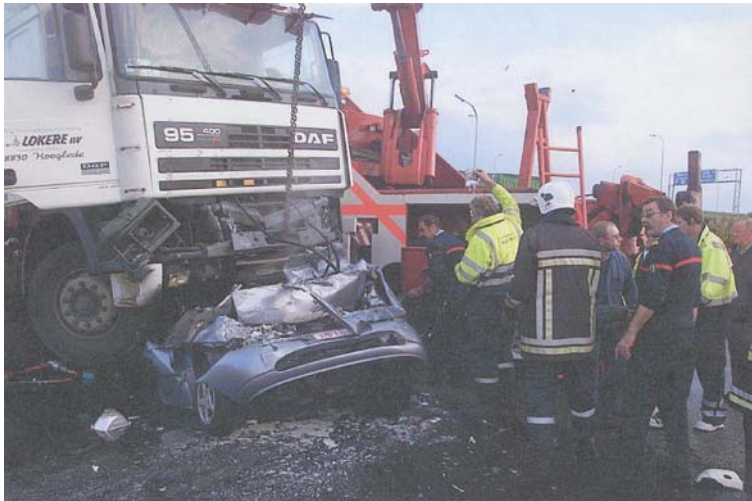
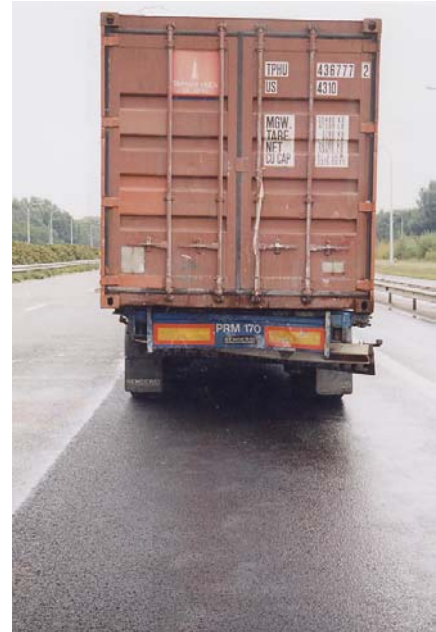
The refrigerator semi-trailer in front was pushed ca. 15 meters forward and shoved a little Ford Fiësta, which stood in front of the refrigerator truck, under a container semi-trailer ahead in the queue.

When compared to the cabin of the incoming tractor, the rear side of the refrigerator semi-trailer was hardly compressed.

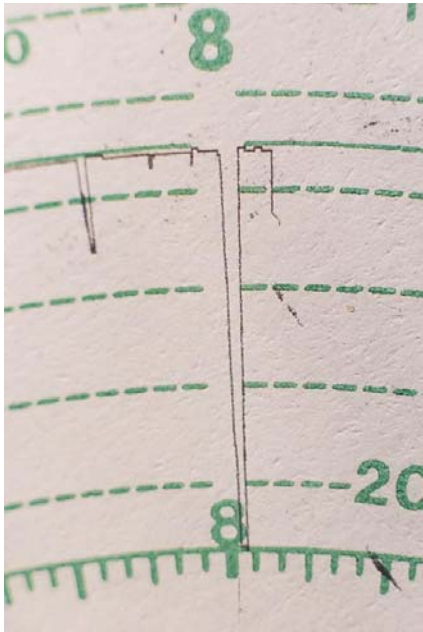
From the speedometer card of the crashing tractor appears that the driver had an initial speed of 88 km/h and that he put the brake only just before the collision. He touched the refrigerator semi-trailer at the end of the queue with a speed of 75 km/h, i.e. the speed at which the speedometer registration disappeared.

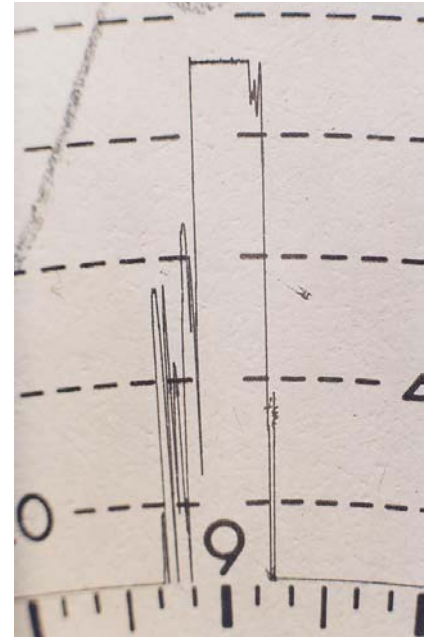
From the speedometer card of the refrigerator semi-trailer appears that this refrigerator semi-trailer was accelerated by the collision up to 35 km/h.

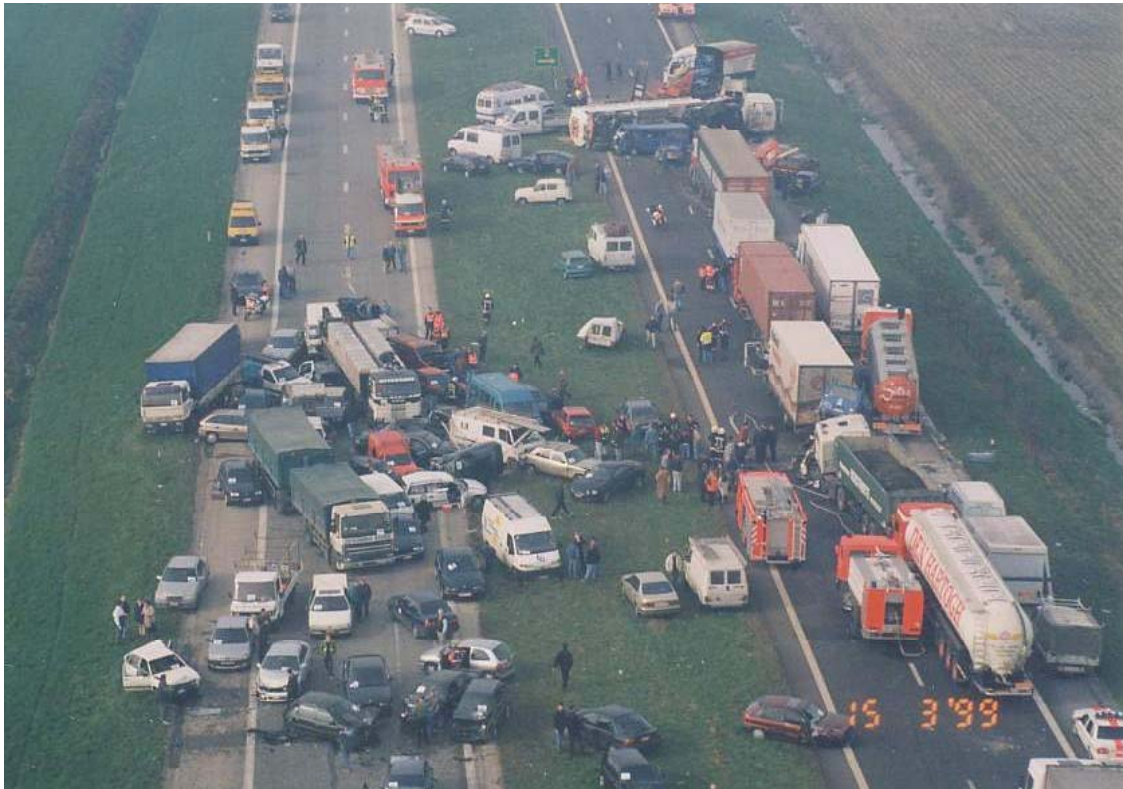
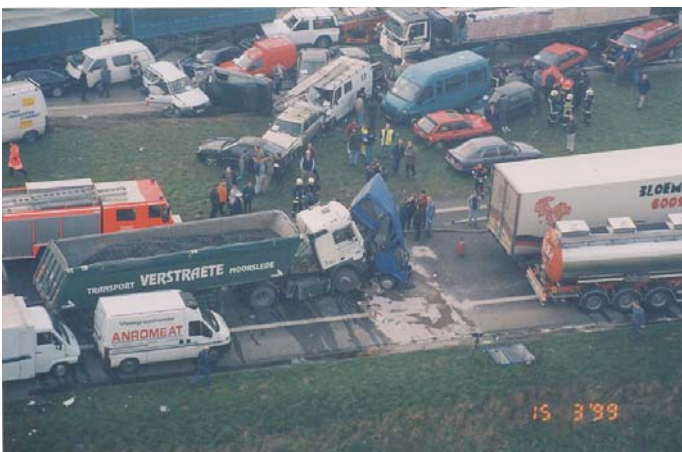
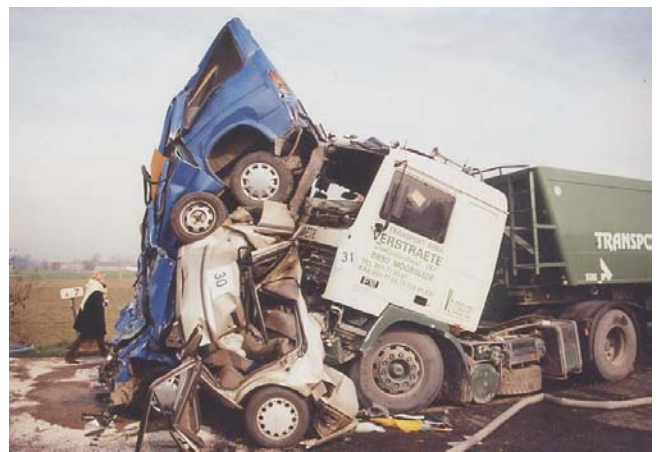
The driver of a semi-trailer, fully loaded with stone-chippings, traveled at a speed of ca. 85 km/h, too fast to stop at the end of the jam, when he could notice it. He put the brakes and touched a first car, which had stopped partly on the hard shoulder, at a speed of about 55 km/h. This car was pushed aside. The semi-trailer then crashed into the end of the queue at a speed of about 30 km/h. A Nissan Sunny car and a Ford Transit van were compressed against the rear end of a Volvo truck that stood third from the last one in the queue. This Volvo truck, according to his speedometer card, was accelerated to a speed of ca. 12,5 km/h.

It was remarkable that the Nissan and the Ford van crashed together precisely in the same way as was already visible in the EVU crash tests in 's Hertogenbosch in Holland in 1996. The Nissan driver in this pile-up collision was as by miracle hardly injured.

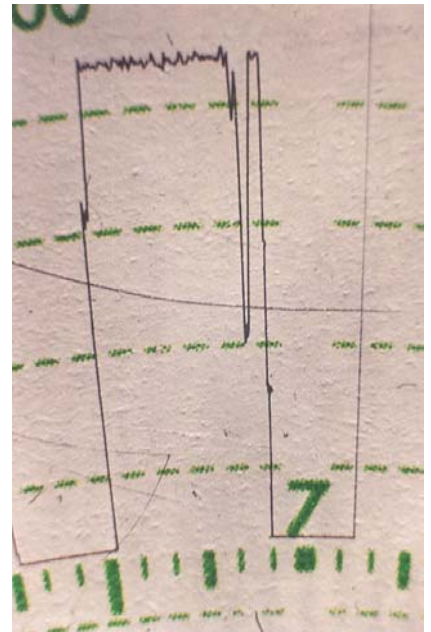
Another point of attention should be the rather weak vibration mark on the card of the speedometer at the moment of collision, when compared to the damage caused by the collision.

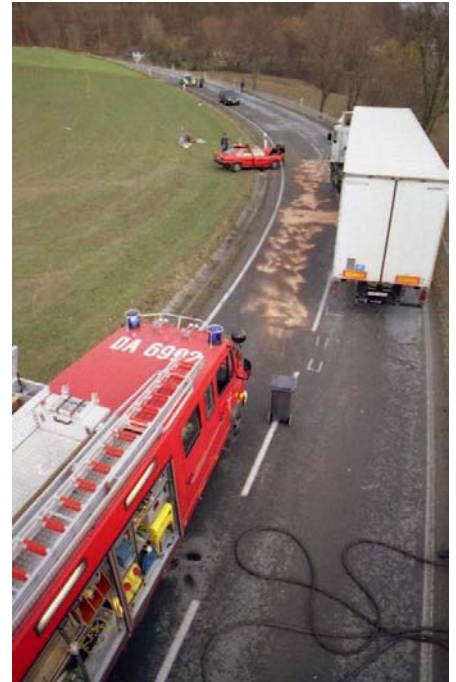
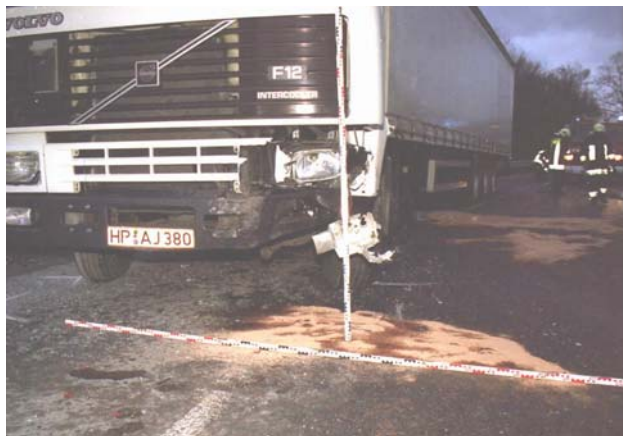
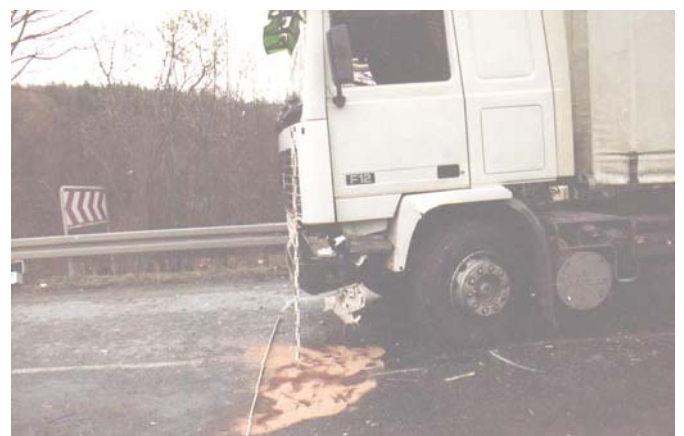
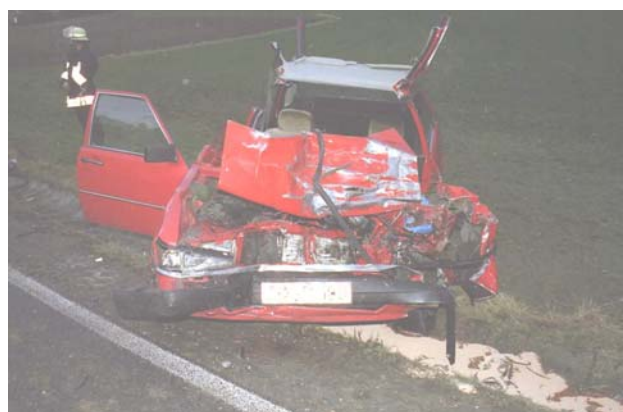
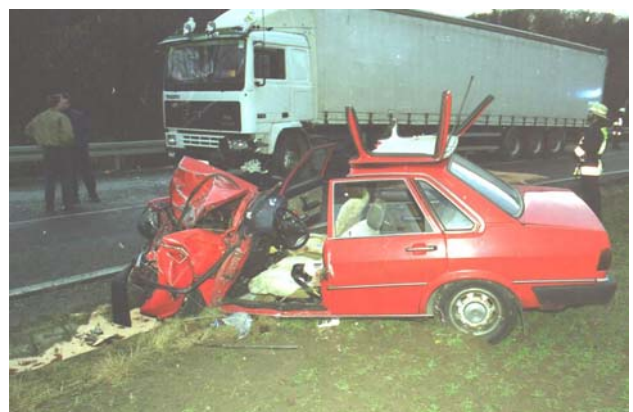
The tractor was hit on the front left corner. The Audi suffered heavy frontal damage. The Audi-driver was badly injured.

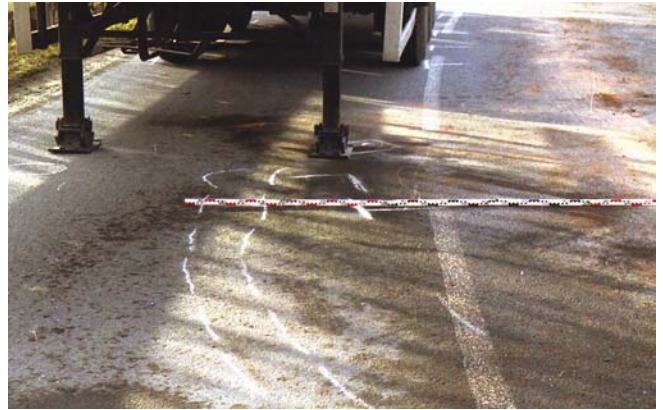
The traces of cooling-water, the tire traces and the scratches in the road surface made clear that the Audi driver had left her right lane with half the width of her car at the moment of impact. She entered the collision apparently without any reaction to avoid it.

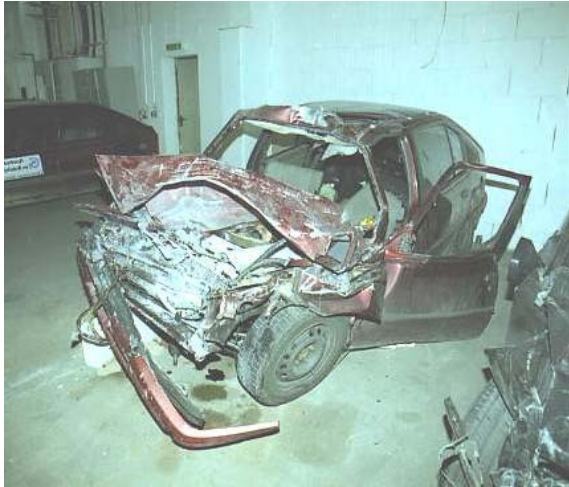
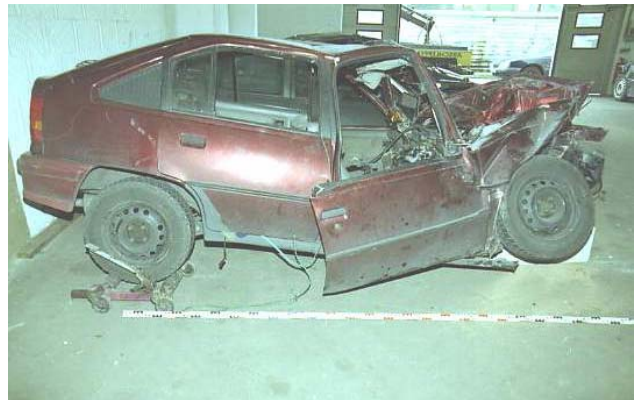
EES Opel Kadett ca. 45 km/h

The Opel was hit at the front. The Opel crashed diagonally into the trucks right front corner.

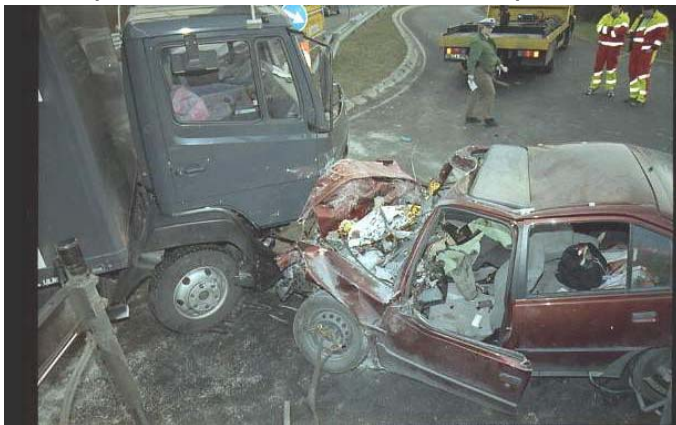
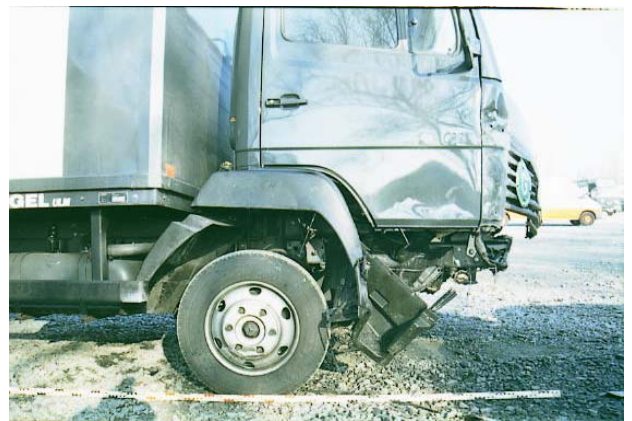
The collision speed of the truck was about 20 km/h (according to the speedometer card).

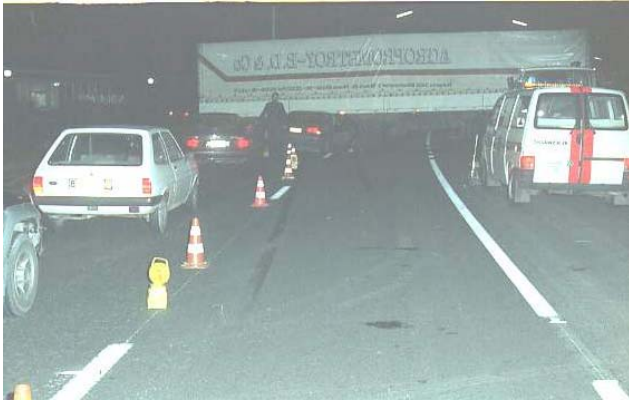
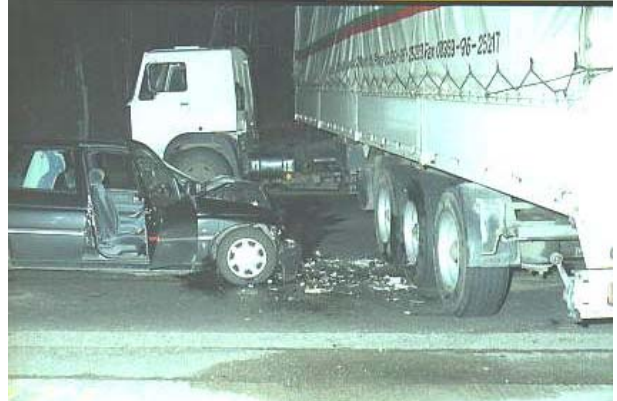
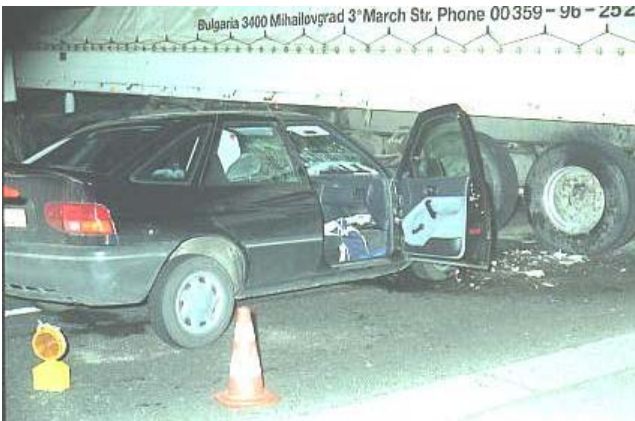
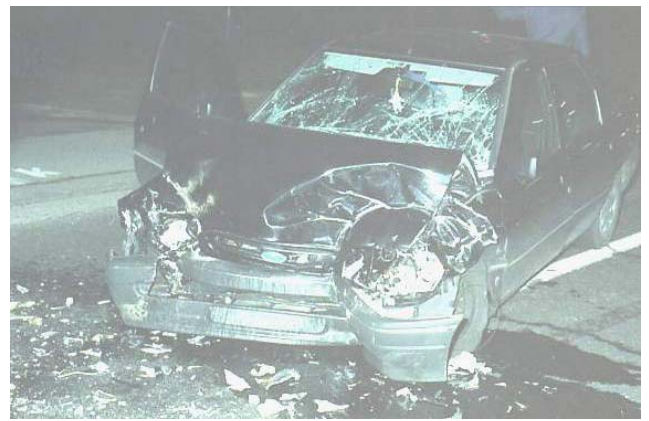
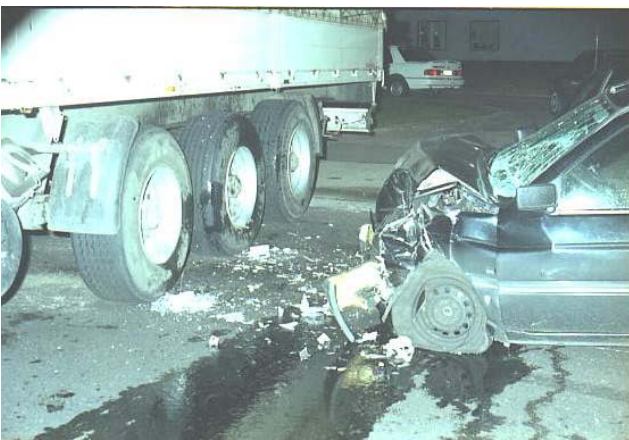
Example: A semi-trailer makes a 180°-turn over the road. A car crashes into the rear wheels of the trailer.

The collision speed of the Ford can be estimated at about 40 km/h.

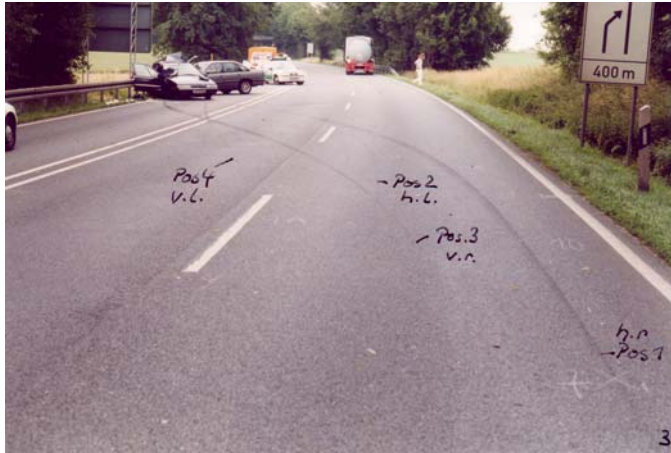
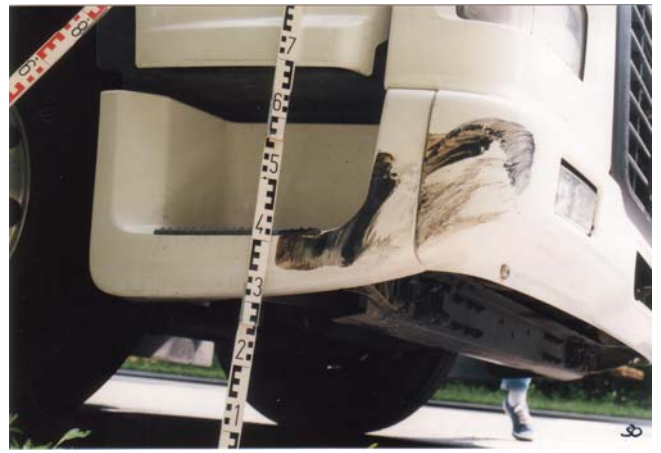
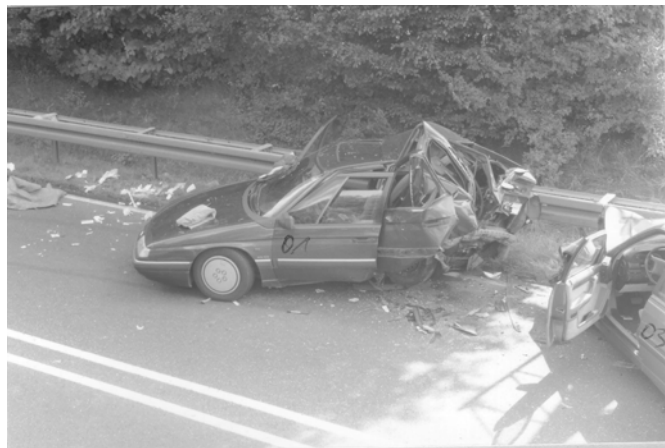
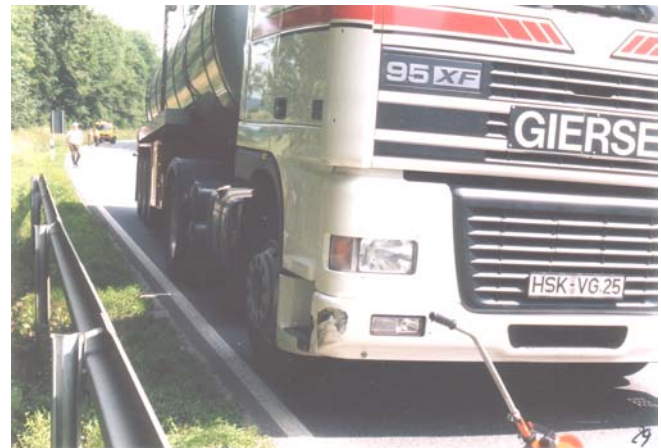
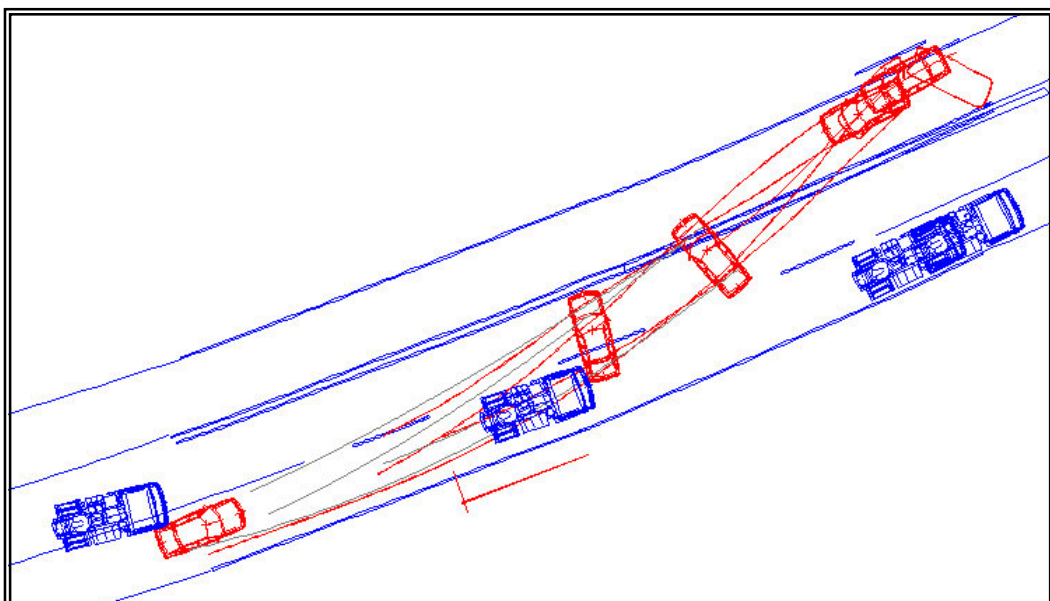
A Citroën XM driver came via a driveway on a priority road. A tractor semi-trailer followed the priority road in the same direction. Both vehicles touched each other in a sliding collision about 250 m past the end of the driveway. The Citroën swerved to the left and was hit at the rear by an Opel Senator following the opposite lane.

In such an accident the problem of the blind spot in the view of the truck driver turns up.
