## EVALUATION OF REAL ACCIDENTS

ir. D. CHRISTIAENS IBB-Expertisen

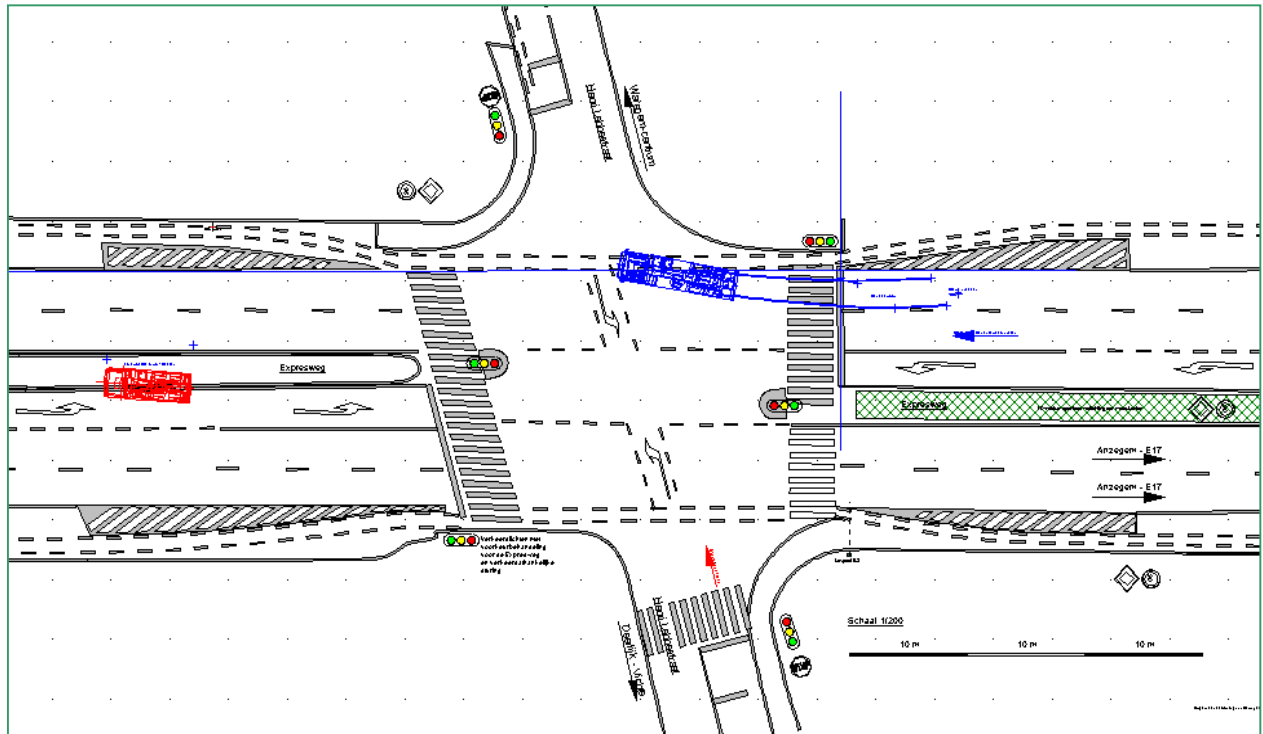
In the collision analysis the calculated deformation energy was divided according to the remaining deformation, about 1,2 m on the Volvo, about 0,2 m on the MAN. Doing this, an EES-value of the damage at the front of the Volvo of about 43 km/h is found. In the same way an EES-value of the damage at the rear of the MAN of about 21 km/h is found.

These values then correspond with a structure stiffness of about 1650 kN/m for the Volvo front and about 10 000 kN/m for the rear end of the MAN tipper.

Whether these values are reliable or not, is difficult to say and test results are very welcome. Moreover the data of the speedometer cards are not always sufficient.

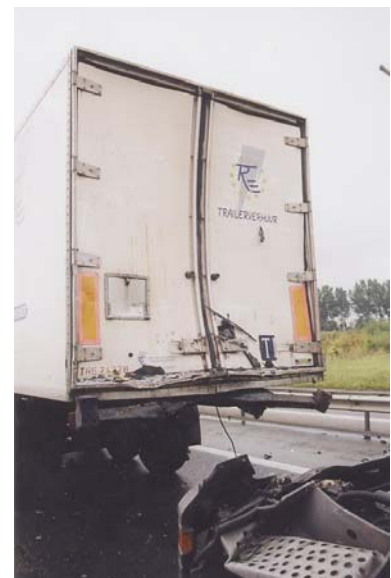
When compared to the cabin of the incoming tractor, the rear side of the refrigerator semi-trailer was hardly compressed.

From the speedometer card of the crashing tractor appears that the driver had an initial speed of 88 km/h and that he put the brake only just before the collision. He touched the refrigerator semi-trailer at the end of the queue with a speed of 75 km/h, i.e. the speed at which the speedometer registration disappeared.

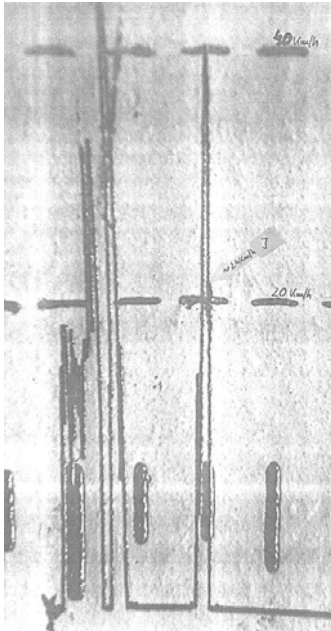
The traces of cooling-water, the tire traces and the scratches in the road surface made clear that the Audi driver had left her right lane with half the width of her car at the moment of impact. She entered the collision apparently without any reaction to avoid it.

The speedometer card of the tractor learned that the driver of the semi-trailer approached the area at a speed of about 50 km/h - the zero line of the speedometer lies too low over about 10 km/h - and that he put the brakes before collision and in this way reduced his speed to ca. 34 km/h at the moment of collision.

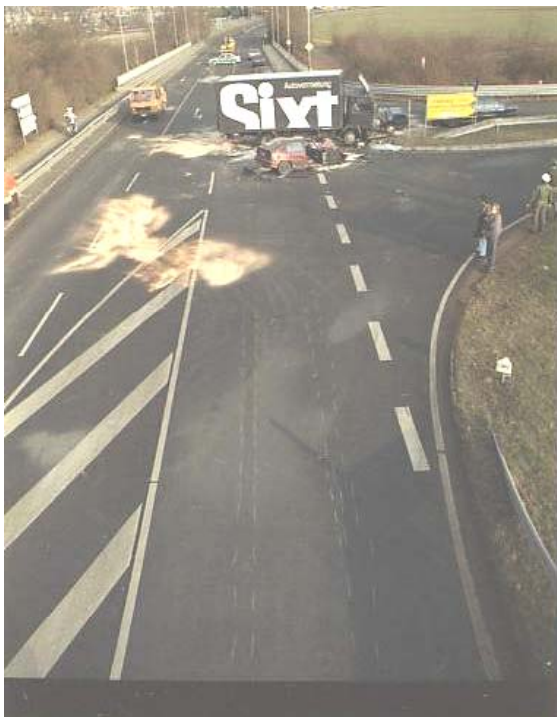
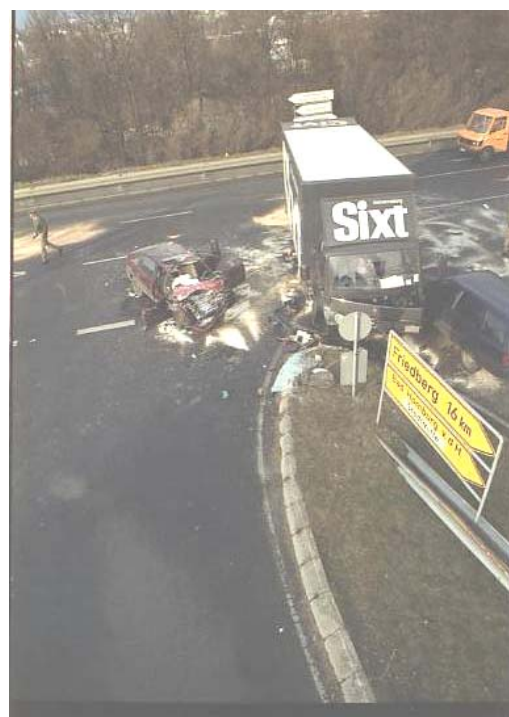
The driver of a truck branched off to the left with the obvious intention to take the side road. A car, an Opel Kadett, which came from the opposite direction, hit the truck. (The truck was a Daimler Benz 814, about 5,1 tons heavy at the moment of the accident.)

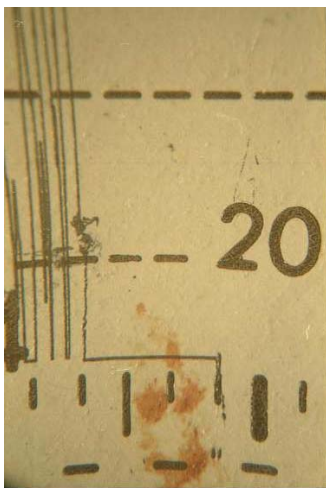
The collision speed of the truck was about 20 km/h (according to the speedometer card).

The collision speed of the car was determined with a calculation program at about 67 km/h.

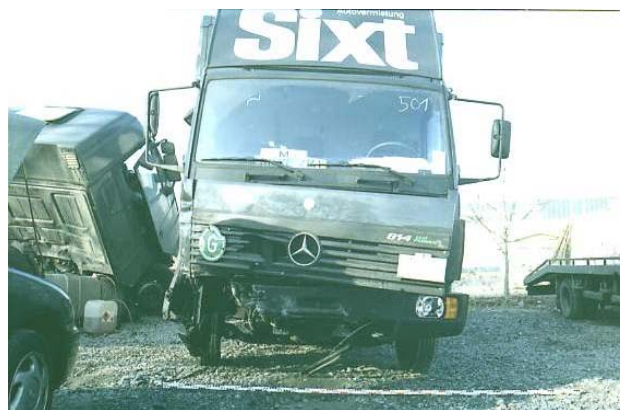
The driver of the Opel put on the brakes before the collision and traveled at a speed of about 97 km/h, before he braking.

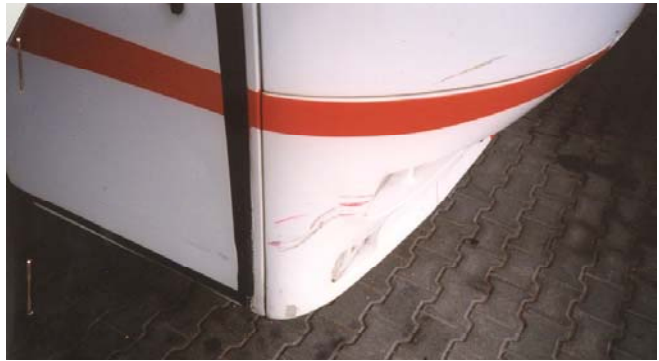
contact traces on the right front corner of the bus

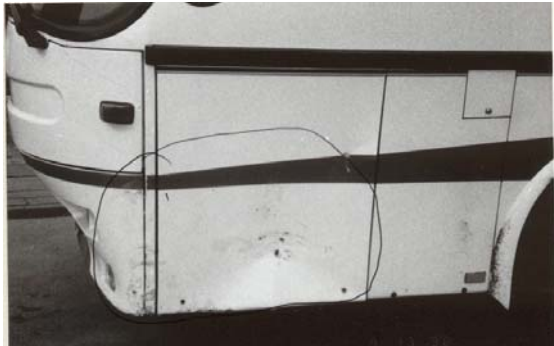
Contact traces on the left front corner of the bus

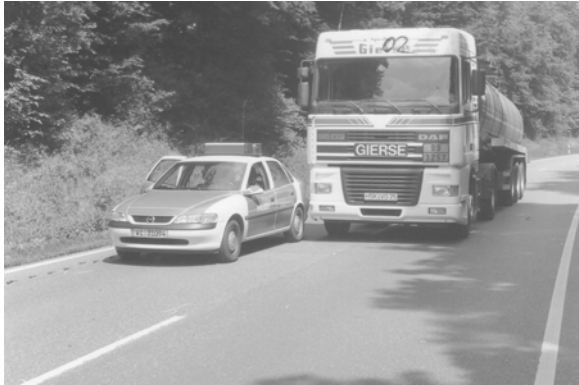
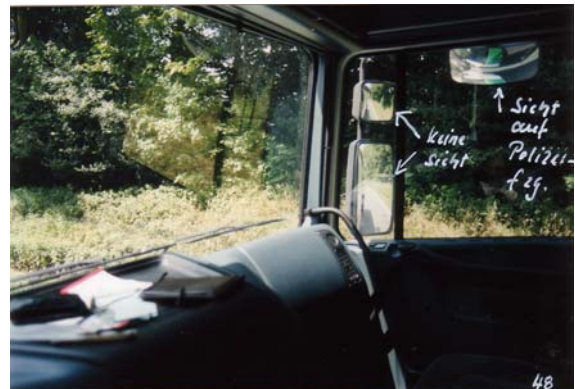
In such an accident the problem of the blind spot in the view of the truck driver turns up.
